VETCAT IMAGING IDENTIFIES UNDETECTED AND UNEXPECTED PATHOLOGY WHERE 2D RADIOGRAPHS WERE INSUFFICIENT

VetCAT CT images identify lesions undetected in conventional radiographs

TREATMENT SNAPSHOT

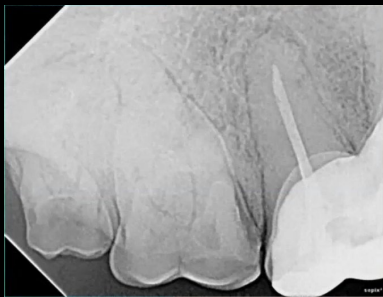
The 2D radiographic images of Cypress's maxillary molars appear to be normal.

Cypress, a 13-year-old Lab, presented for a follow-up of previous crowns and root canal therapies. Conventional 2D radiographs of her maxillary molars provided insufficient information to the actual pathology of Cypress's case.

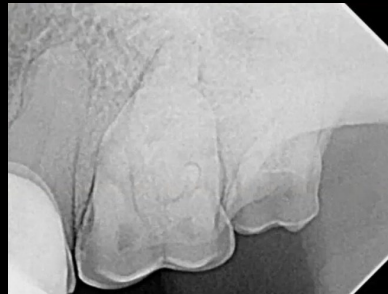
With so much bone density and overlapping of the roots, it is difficult to appreciate the pathology that exists.

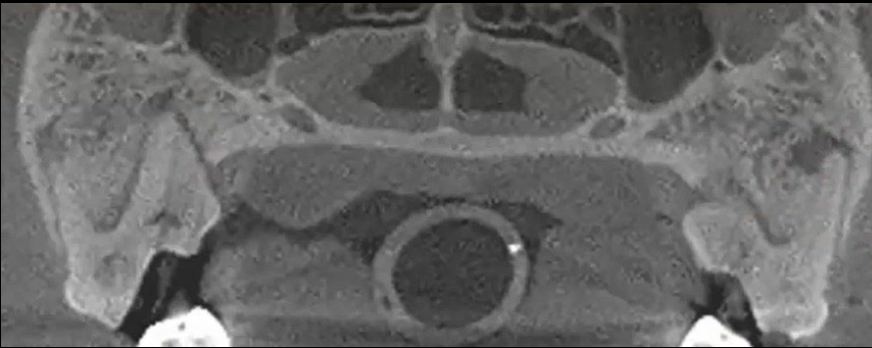
Visible periapical lesions on each of the maxillary molars are now visible with the VetCAT cone beam imaging. Both molars were extracted and were found to be necrotic and non-vital on the inside.

"This is one of those cases where we are finding things on these images when we are not expecting it. I'm finding this to be quite common when radiographs appear normal, but has pathology on the cone beam CT."
-Dr. Kris Bannon
